Investigative Report by the Accident Investigation Committee for the Explosion & Fire Accident occurred in the High-Purity Polycrystalline Silicon Manufacturing Facility at Yokkaichi Plant of Mitsubishi Materials Corporation

(Abridged Version)

June 12, 2014

Accident Investigation Committee

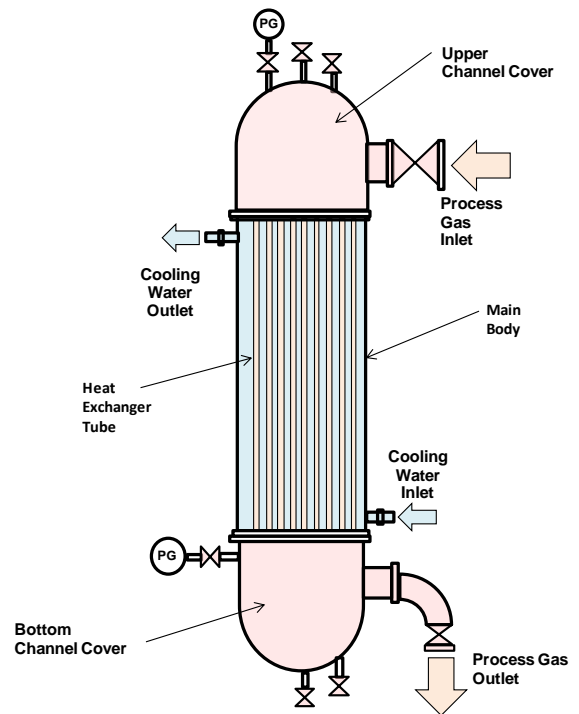
Fig. 2. Structural overview of heat exchanger (BH-HE-611)

As shown in Fig.2., multiple heat exchanger tubes were positioned inside the water-cooled heat exchanger. Process gases discharged from the reactor flowed through the heat exchanger tubes and were cooled by water flowing in the opposite direction on the outside.

The hydrolyzed products of chlorosilane polymers were ignited and exploded due to impact occurred at the flange surface where the upper channel cover was fastened to the body of the heat exchanger  
→The top channel cover was sent flying.

→The blast shattered glass windows at the nearby building. Chlorosilane polymers remaining inside the heat exchanger were then sent flying.

→Combustible materials from chlorosilane polymers erupted into the atmosphere, burned and created a fireball.

1. The amount of chlorosilane polymers is measured. The hydrolysis process time and amount of generated gas is calculated. During transportation to the maintenance area, a safe condition should be created using inert gas enclosure. At the maintenance area, required pipes, etc. are connected.

2. Hydrolysis should be conducted while keeping the inside of the heat exchanger full of water. After filling the exchanger with water, a water temperature of approximately 40 degrees Celsius is maintained during hydrolysis. Appropriate data are measured and monitored. The ending point for hydrolysis is determined from pH and hydrogen concentration.

3. The channel cover is opened by remote control.
4. High-pressure water is used to wash away chlorosilane polymers and the hydrolysis products of chlorosilane polymers from inside the heat exchanger. Wastewater is discharged into a sump pit under moist conditions.

- Installation of protective walls against the explosion.
- Enable safe processing of exhaust gas.
- Enable opening of the channel cover using remote control.
- Enable temperature control and monitoring of hydrolysis.
